Debris/Ice/TPS Assessment and Integrated Photographic Analysis of Shuttle Mission STS-92

**DEBRIS/ICE/TPS ASSESSMENT
AND
INTEGRATED PHOTOGRAPHIC ANALYSIS
OF
SHUTTLE MISSION STS-92**

11 October 2000

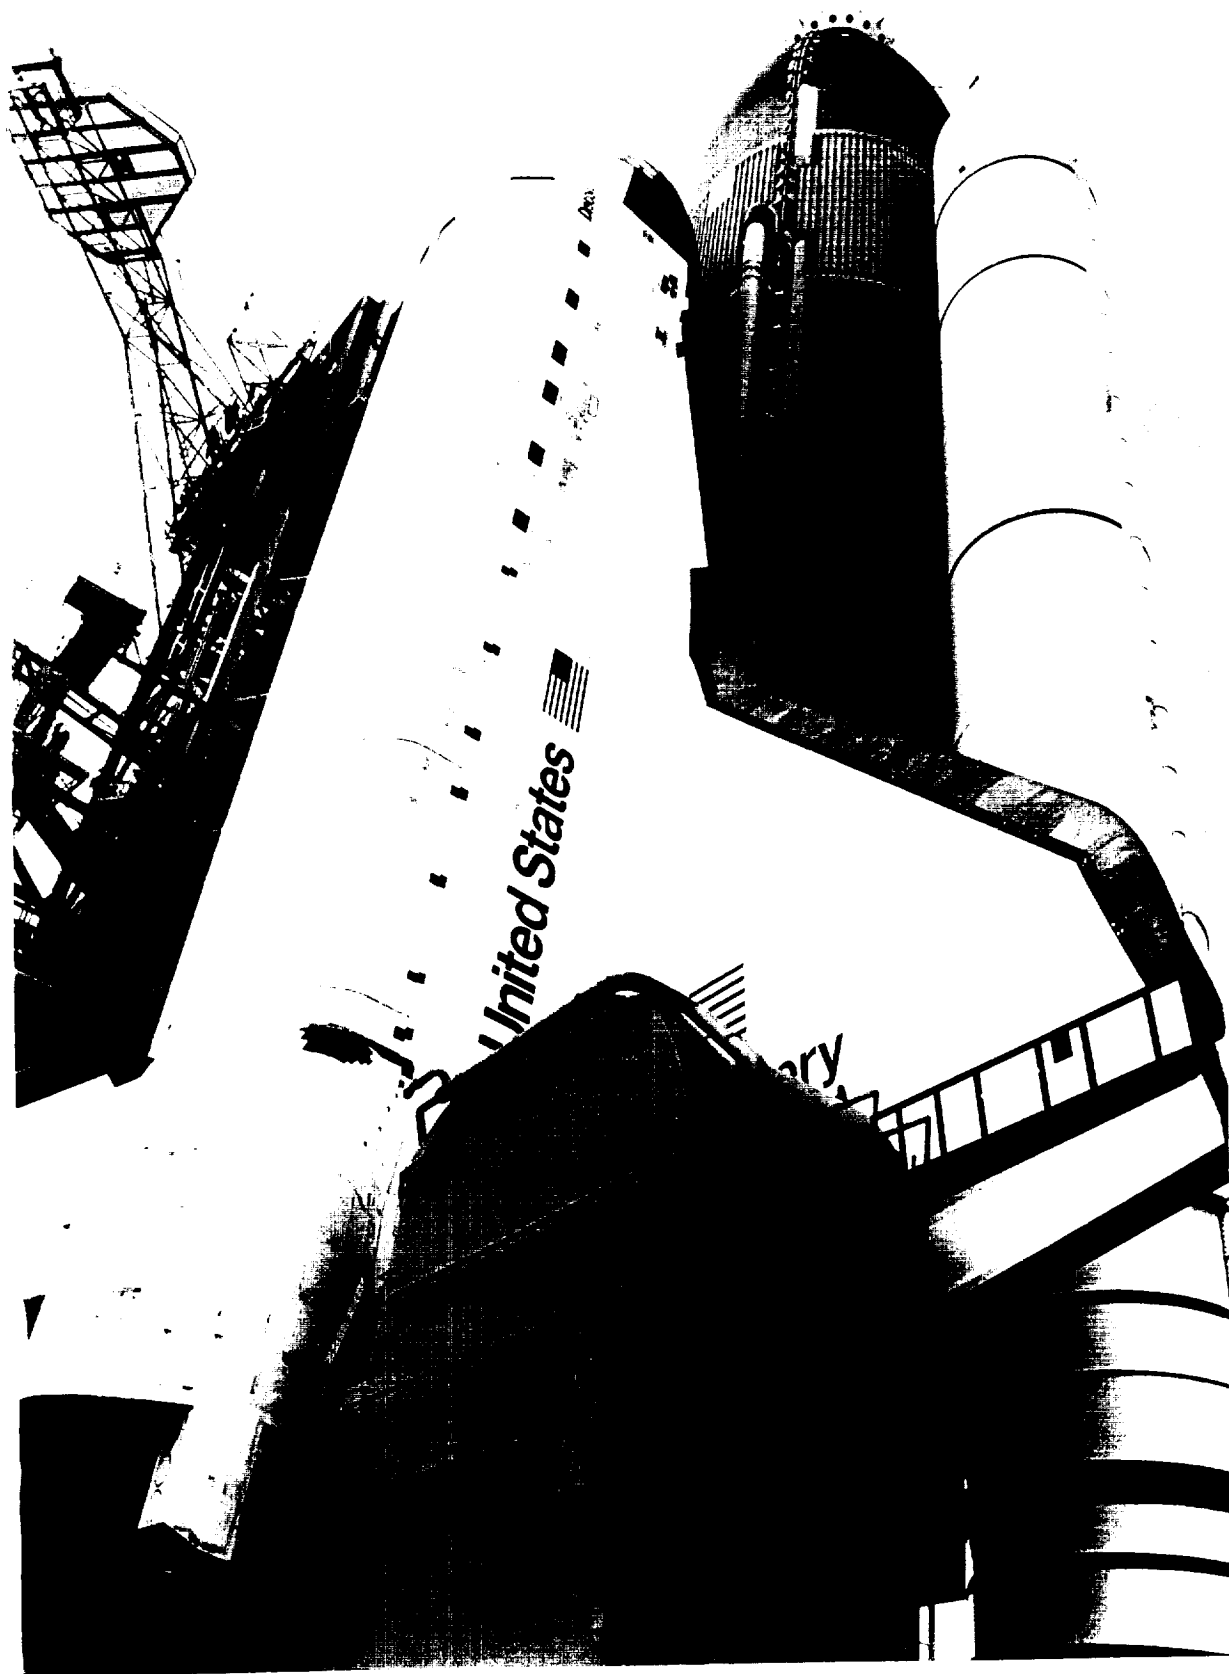
Photo 5: External Tank After Cryoload

No significant anomalies were present in the intertank TPS. The 14 stringer valley TPS cracks including the two located in between the bipods detected during the previous cryoload had increased to a total of 16. Ice and frost accumulations on the GUCP were typical.

During this second cryogenic loading, the Final Inspection Team observed light condensate on the LO₂ and LH₂ tank acreage. Surface temperatures ranged from 54 to 65 degrees F. The 14 stringer valley TPS cracks including the two located in between the bipods detected during the previous cryoload had increased to a total of 16.

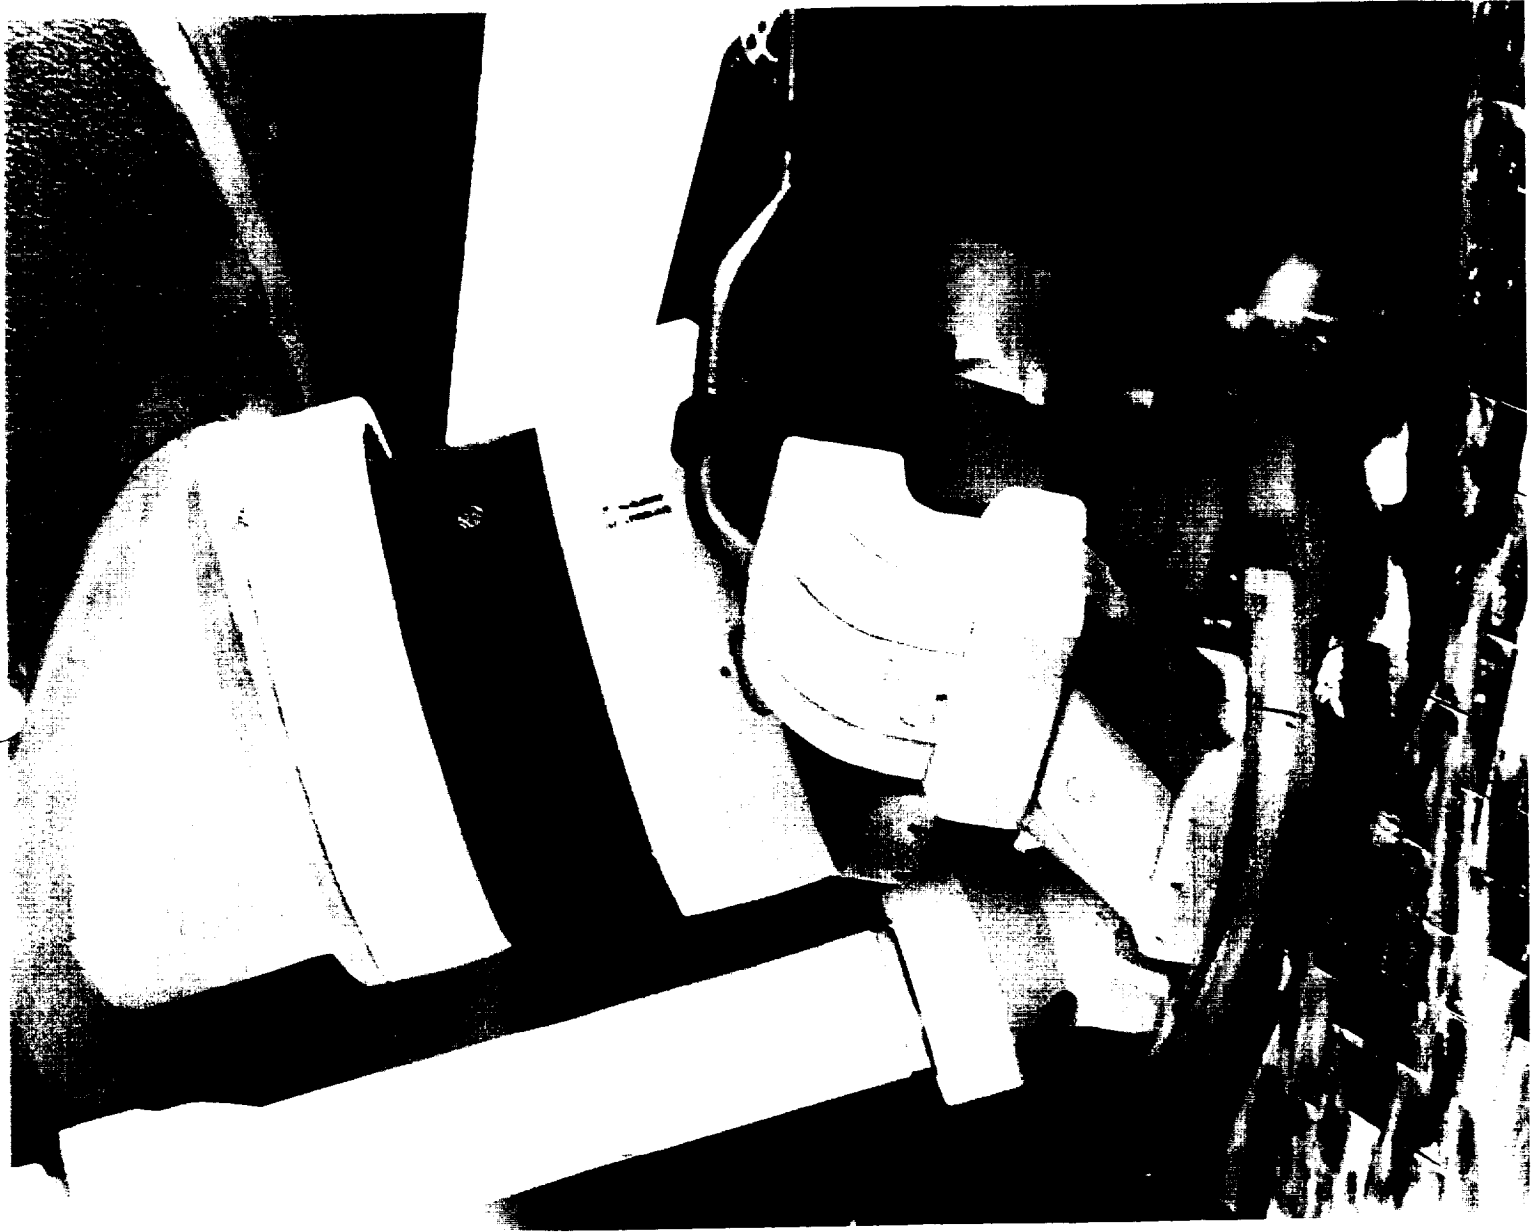
Photo 6: LH2 ET/ORB Umbilical

Ice and frost in the LH2 recirculation line bellows and on both burst disks was typical. Likewise, a typical amount of ice/frost had accumulated on the LH2 ET/ORB umbilical purge barrier outboard side, forward, and aft surfaces. Typical ice/frost fingers were present on the pyro canister and plate gap purge vents. No unusual vapors or cryogenic drips had appeared during tanking, stable replenish, and launch.

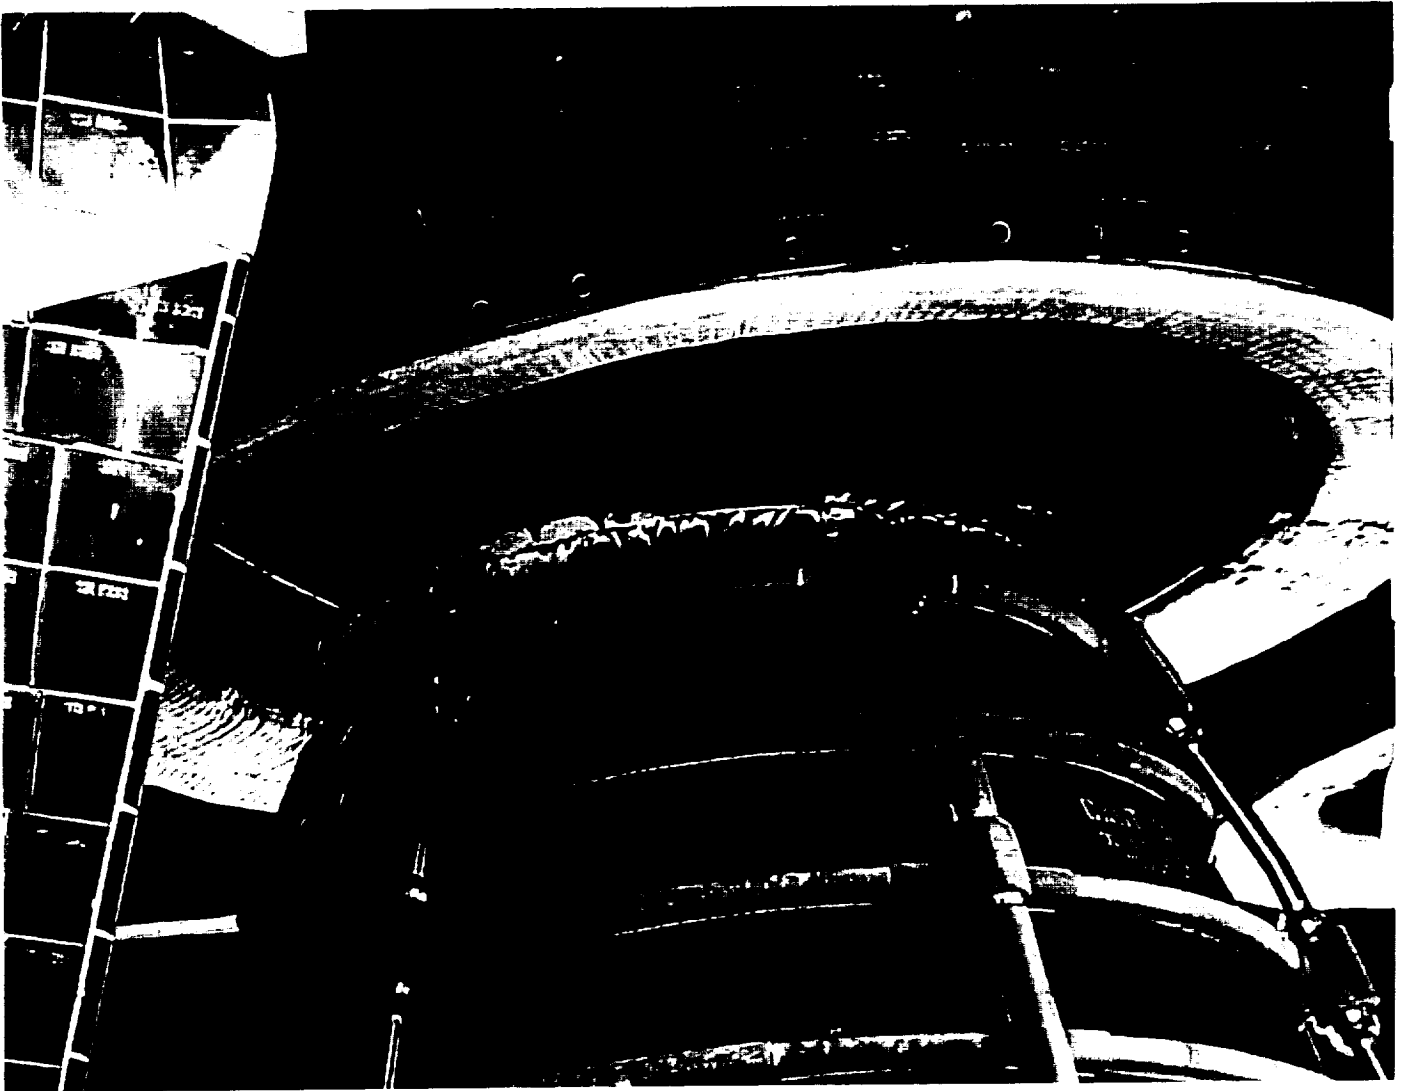
Photo 8: SSME #2

Ice/frost had formed on the SSME #1 and #2 heat shield-to-nozzle interfaces

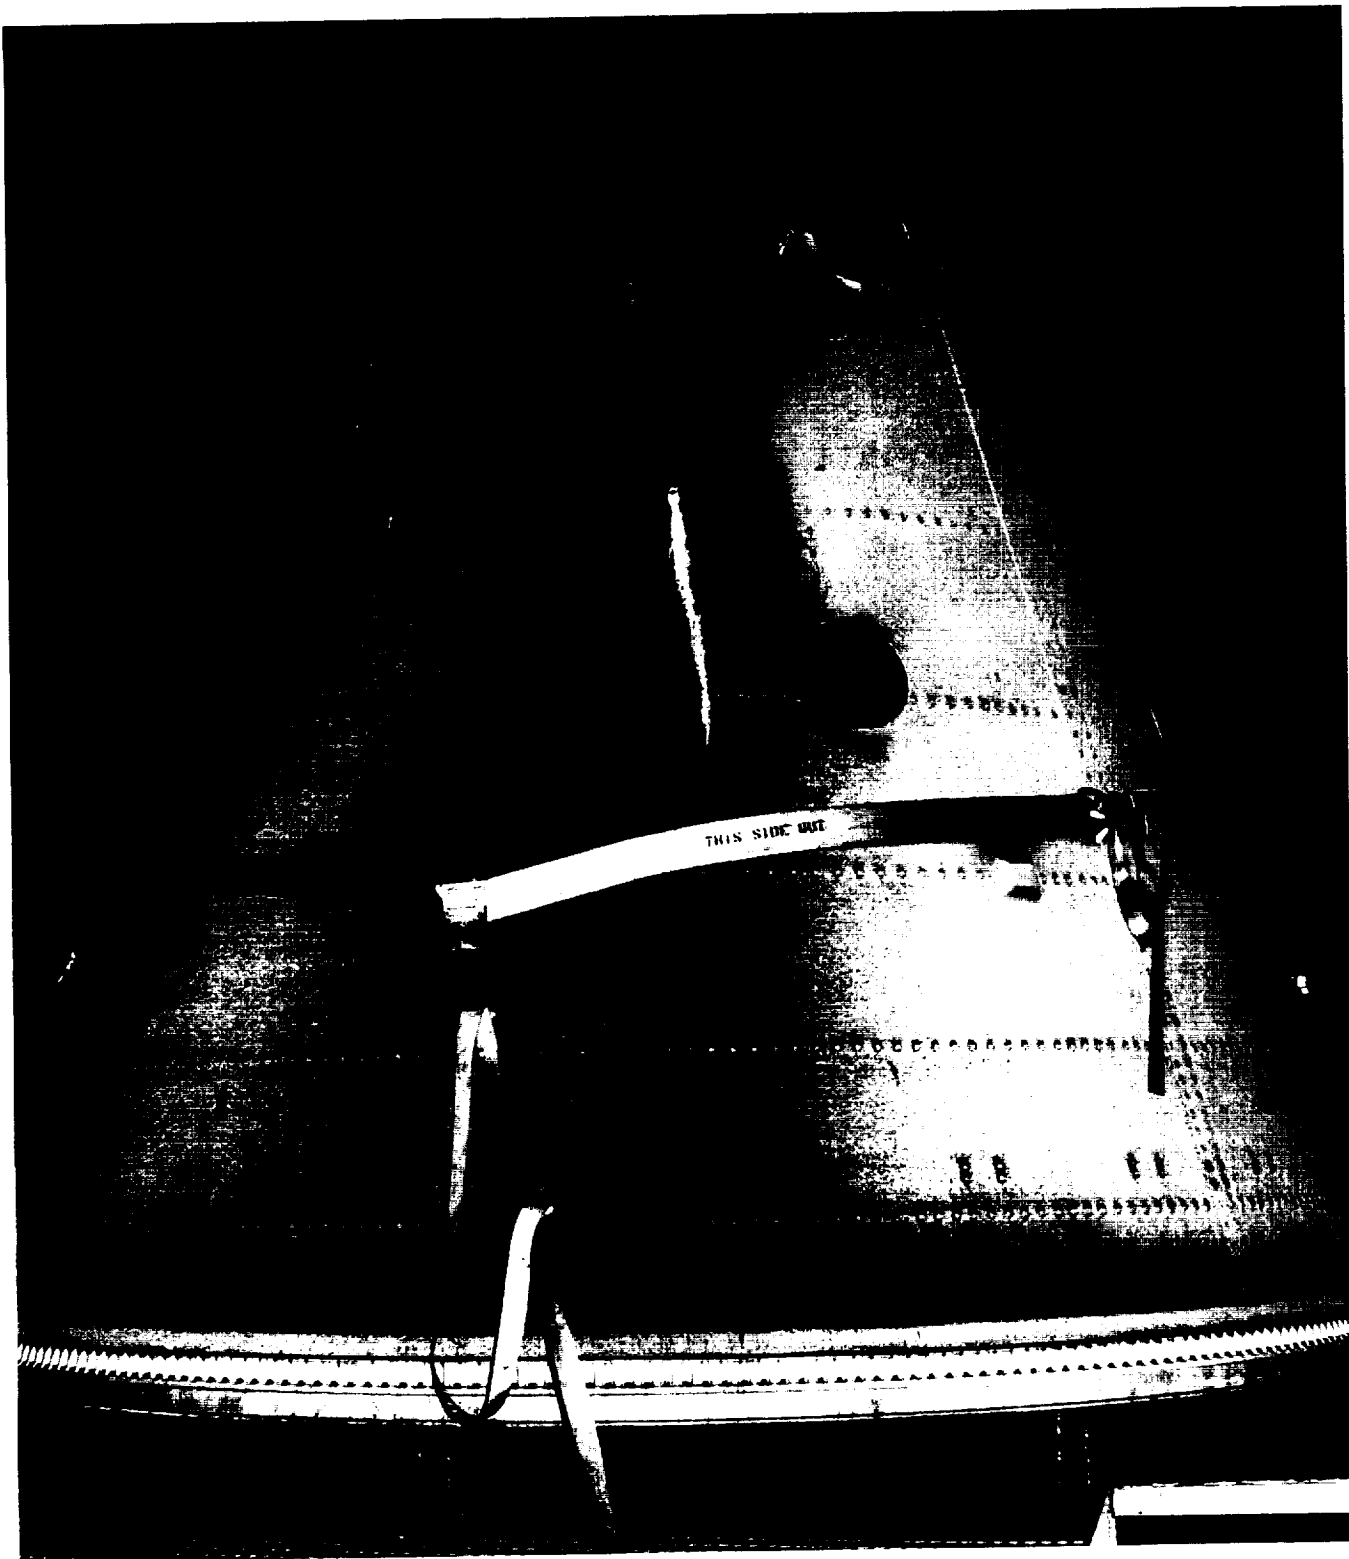
Photo 11: Frustum Post Flight Condition

The frustums exhibited no debonds/unbonds or missing TPS.
All eight BSM aero heat shield covers had locked in the fully opened position.

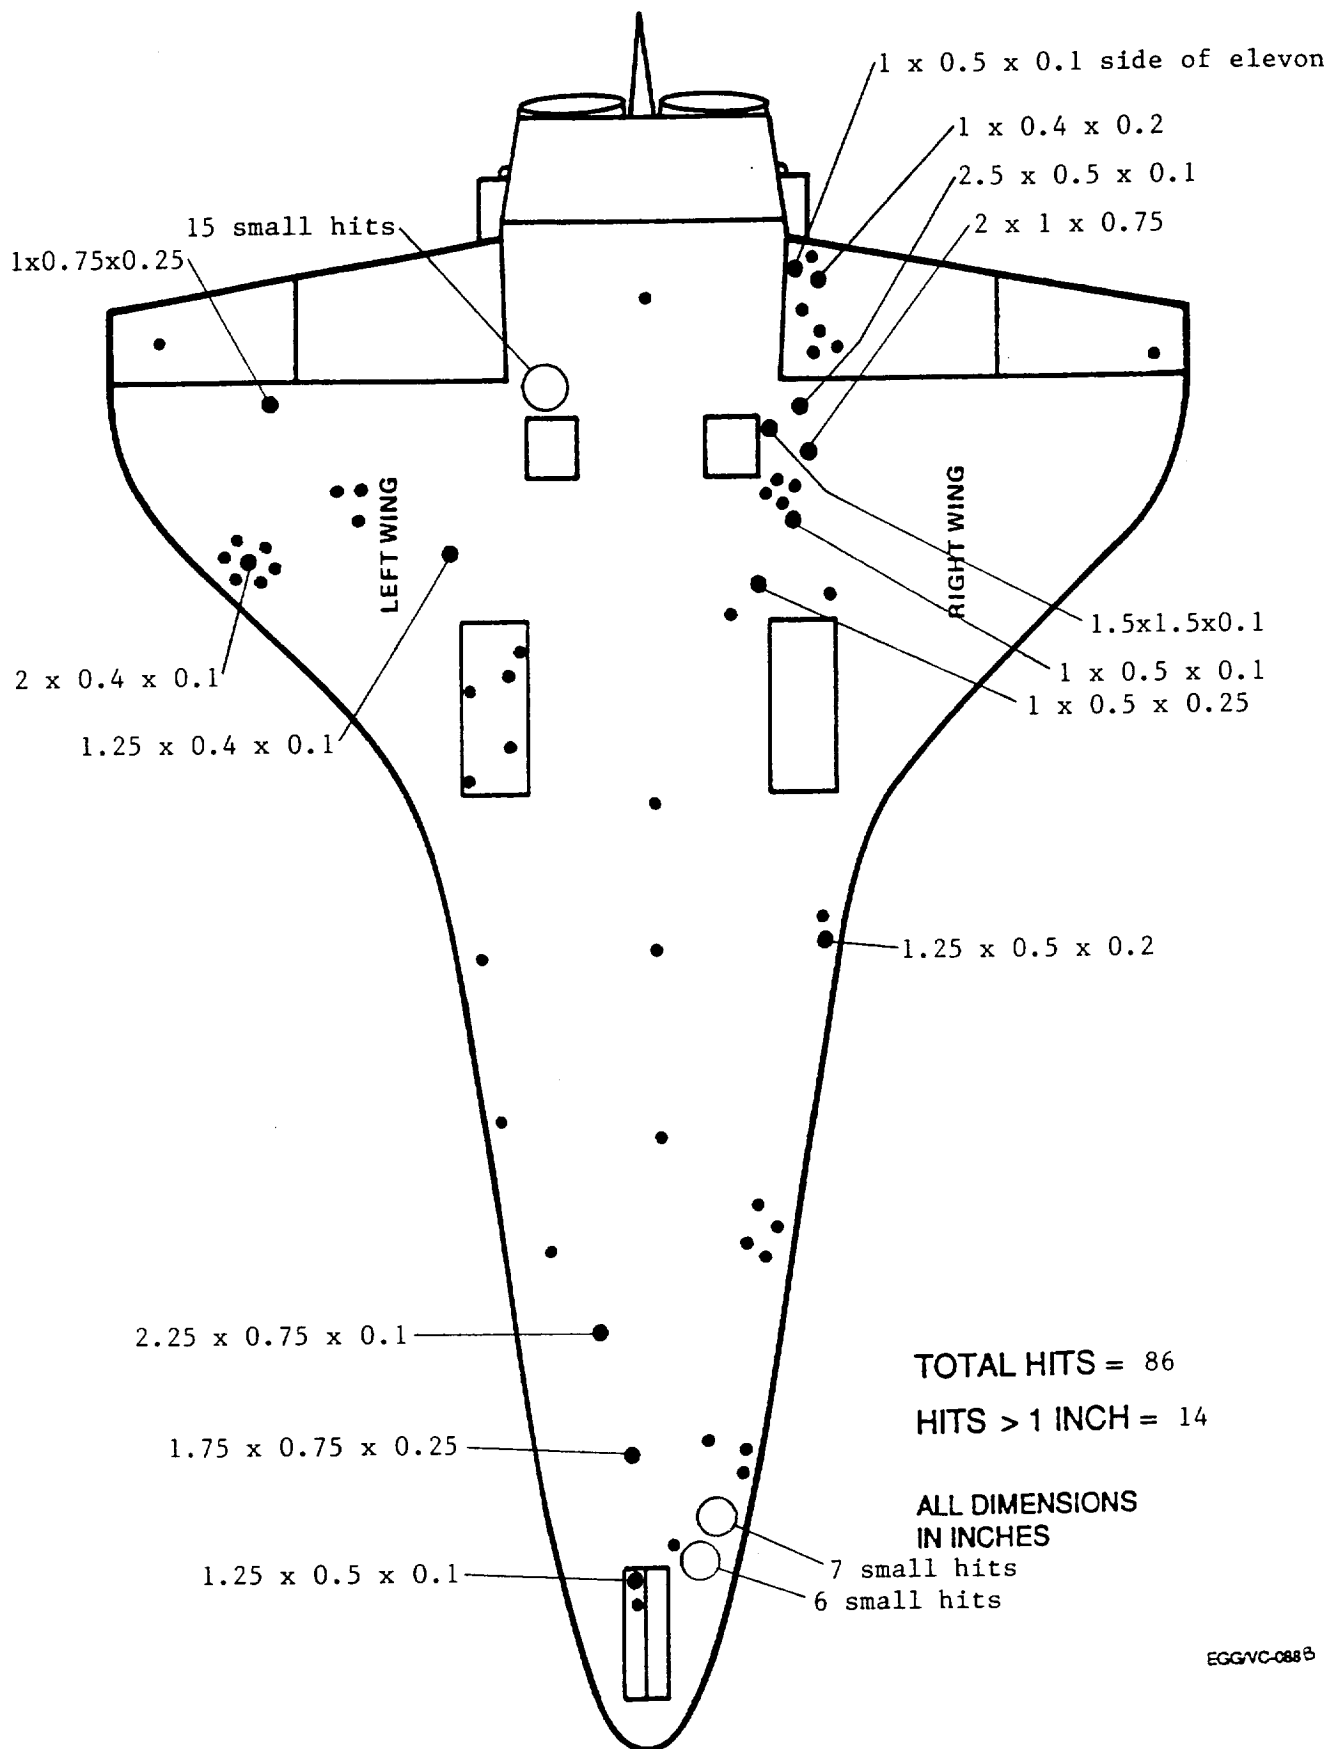
Figure 1: Orbiter Lower Surface Debris Damage Map

Post landing inspection of Orbiter tiles showed a total of 127 hits, of which 24 had a major dimension of 1-inch or larger. The Orbiter lower surface sustained 86 total hits, of which 14 had a major dimension of 1-inch or larger. Approximately 33 damage sites (with three larger than 1-inch in length) were located in the area from the nose gear to the main landing gear wheel wells. The majority of this damage occurred on the right-hand side of the vehicle, though some of these hits may be attributed to impacts from ice in the LO2 feedline bellows. ET TPS venting modifications continue to have a reducing effect on the quantity and size of the damage sites.

The largest lower surface tile damage site, located on the right wing just outboard of the LO2 umbilical door, measured 2-inches long by 1-inch wide by 0.75-inches deep. The cause of this damage site is believed to be ice from the ET LO2 feedline bellows.

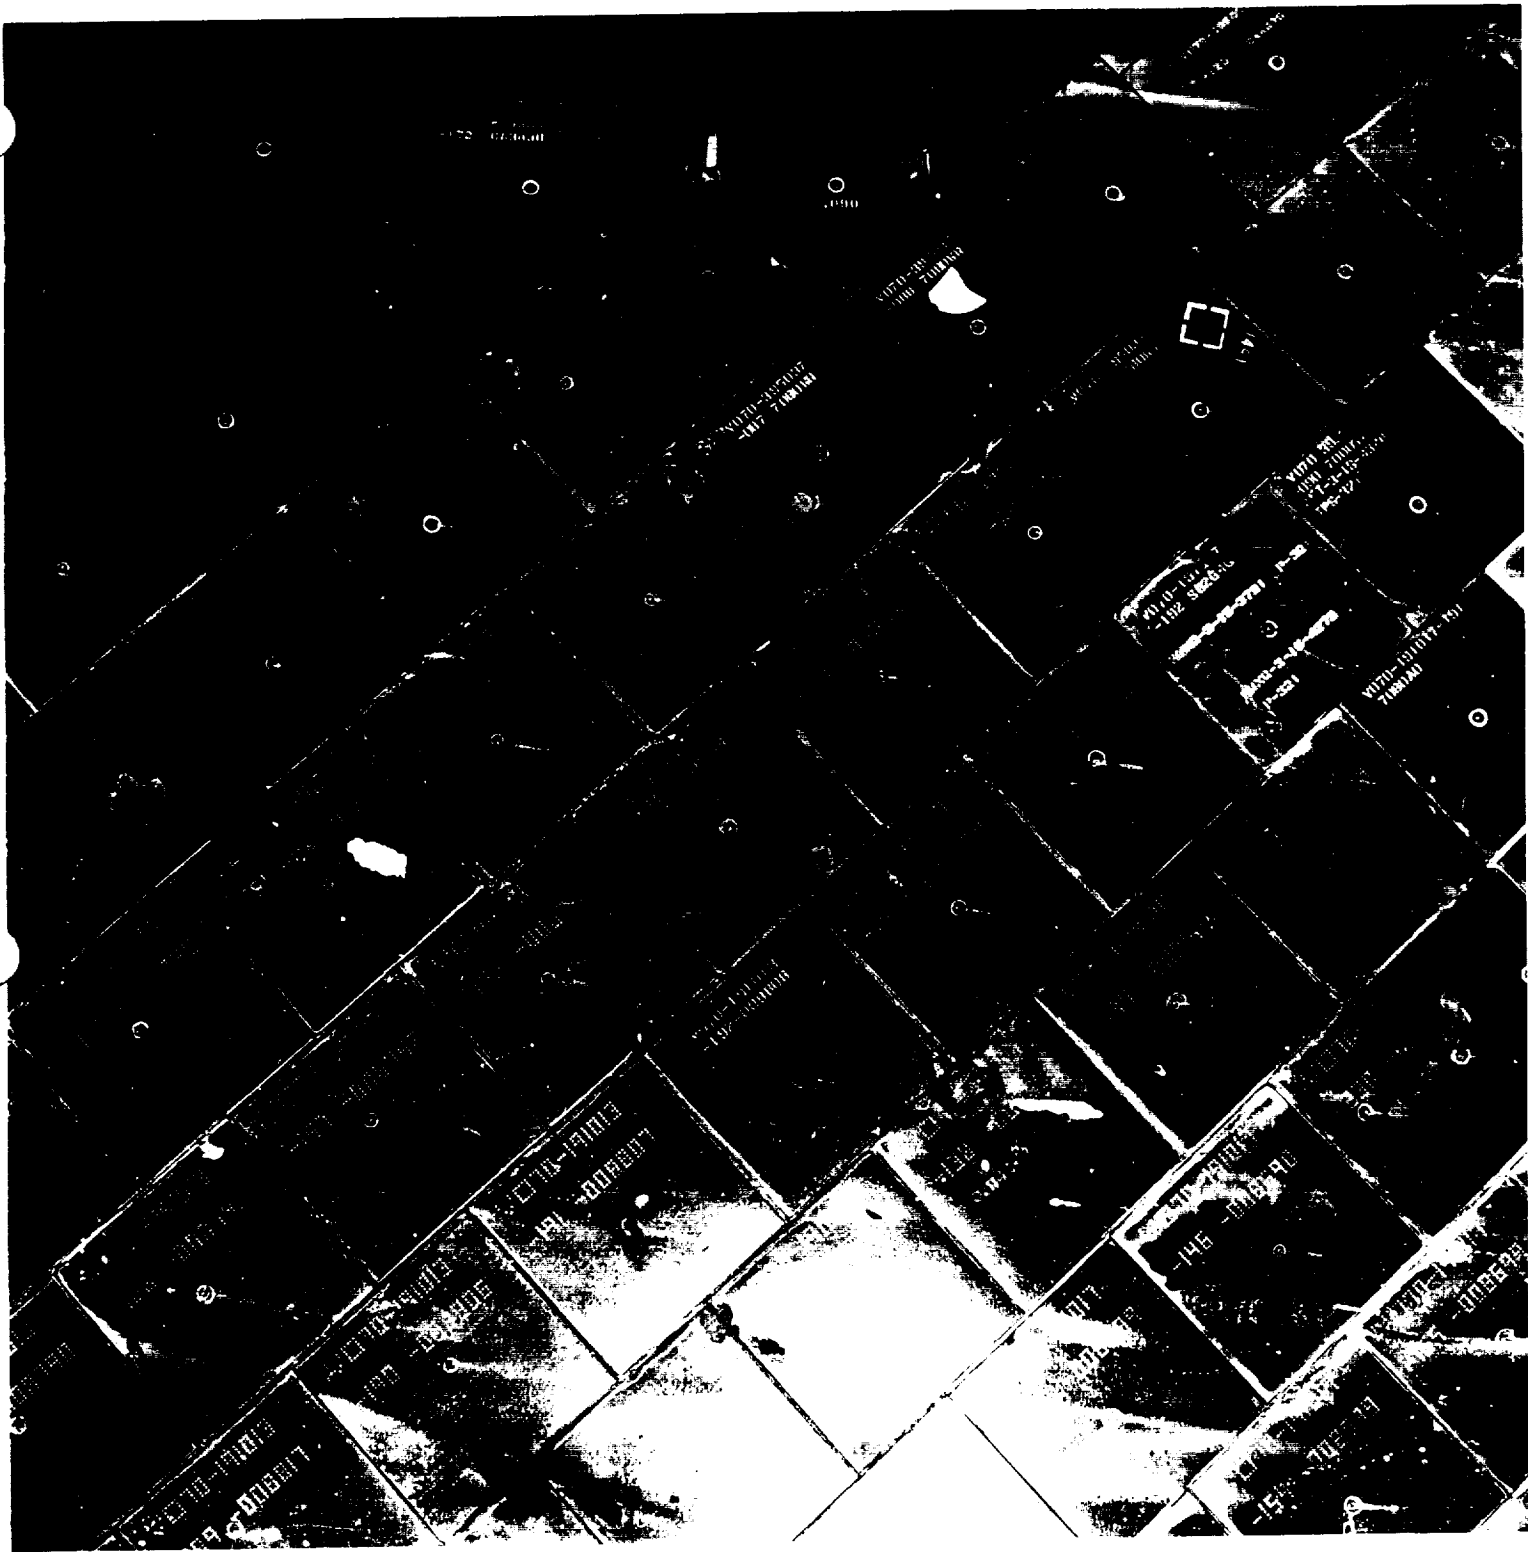
Photo 17: Damage to Lower Surface Tiles

The Orbiter lower surface sustained 86 total hits, of which 14 had a major dimension of 1-inch or larger. Approximately 33 damage sites (with three larger than 1-inch in length) were located in the area from the nose gear to the main landing gear wheel wells. The majority of this damage occurred on the right-hand side of the vehicle, though some of these hits may be attributed to impacts from ice in the LO2 feedline bellows. ET TPS venting modifications continue to have a reducing effect on the quantity and size of the damage sites.

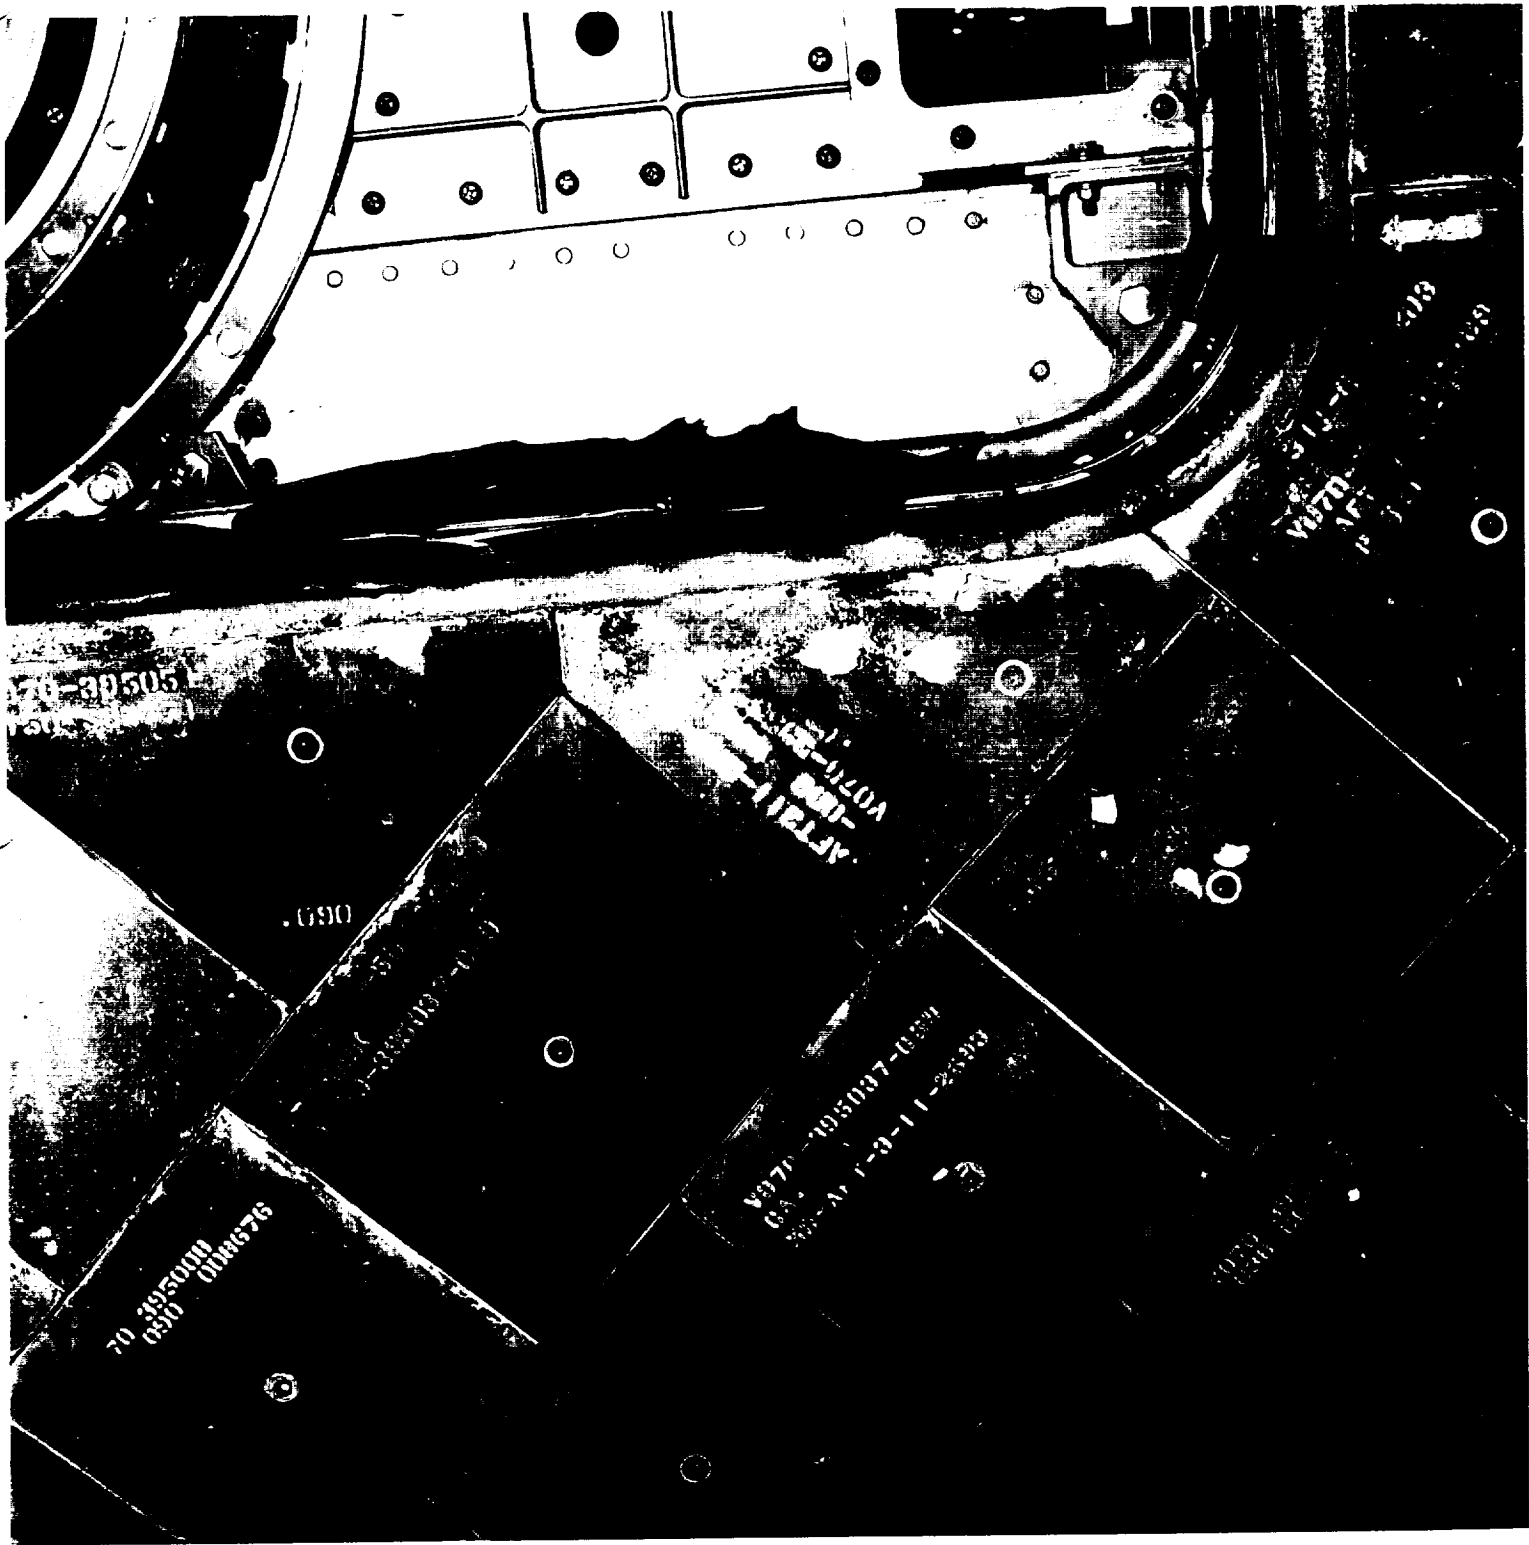
Photo 18: Tile Damage Near Umbilicals

Numerous tile damage sites around the LH2 ET/ORB umbilical were most likely caused by pieces of the umbilical purge barrier flailing in the airstream and contacting tiles before pulling loose and falling aft.

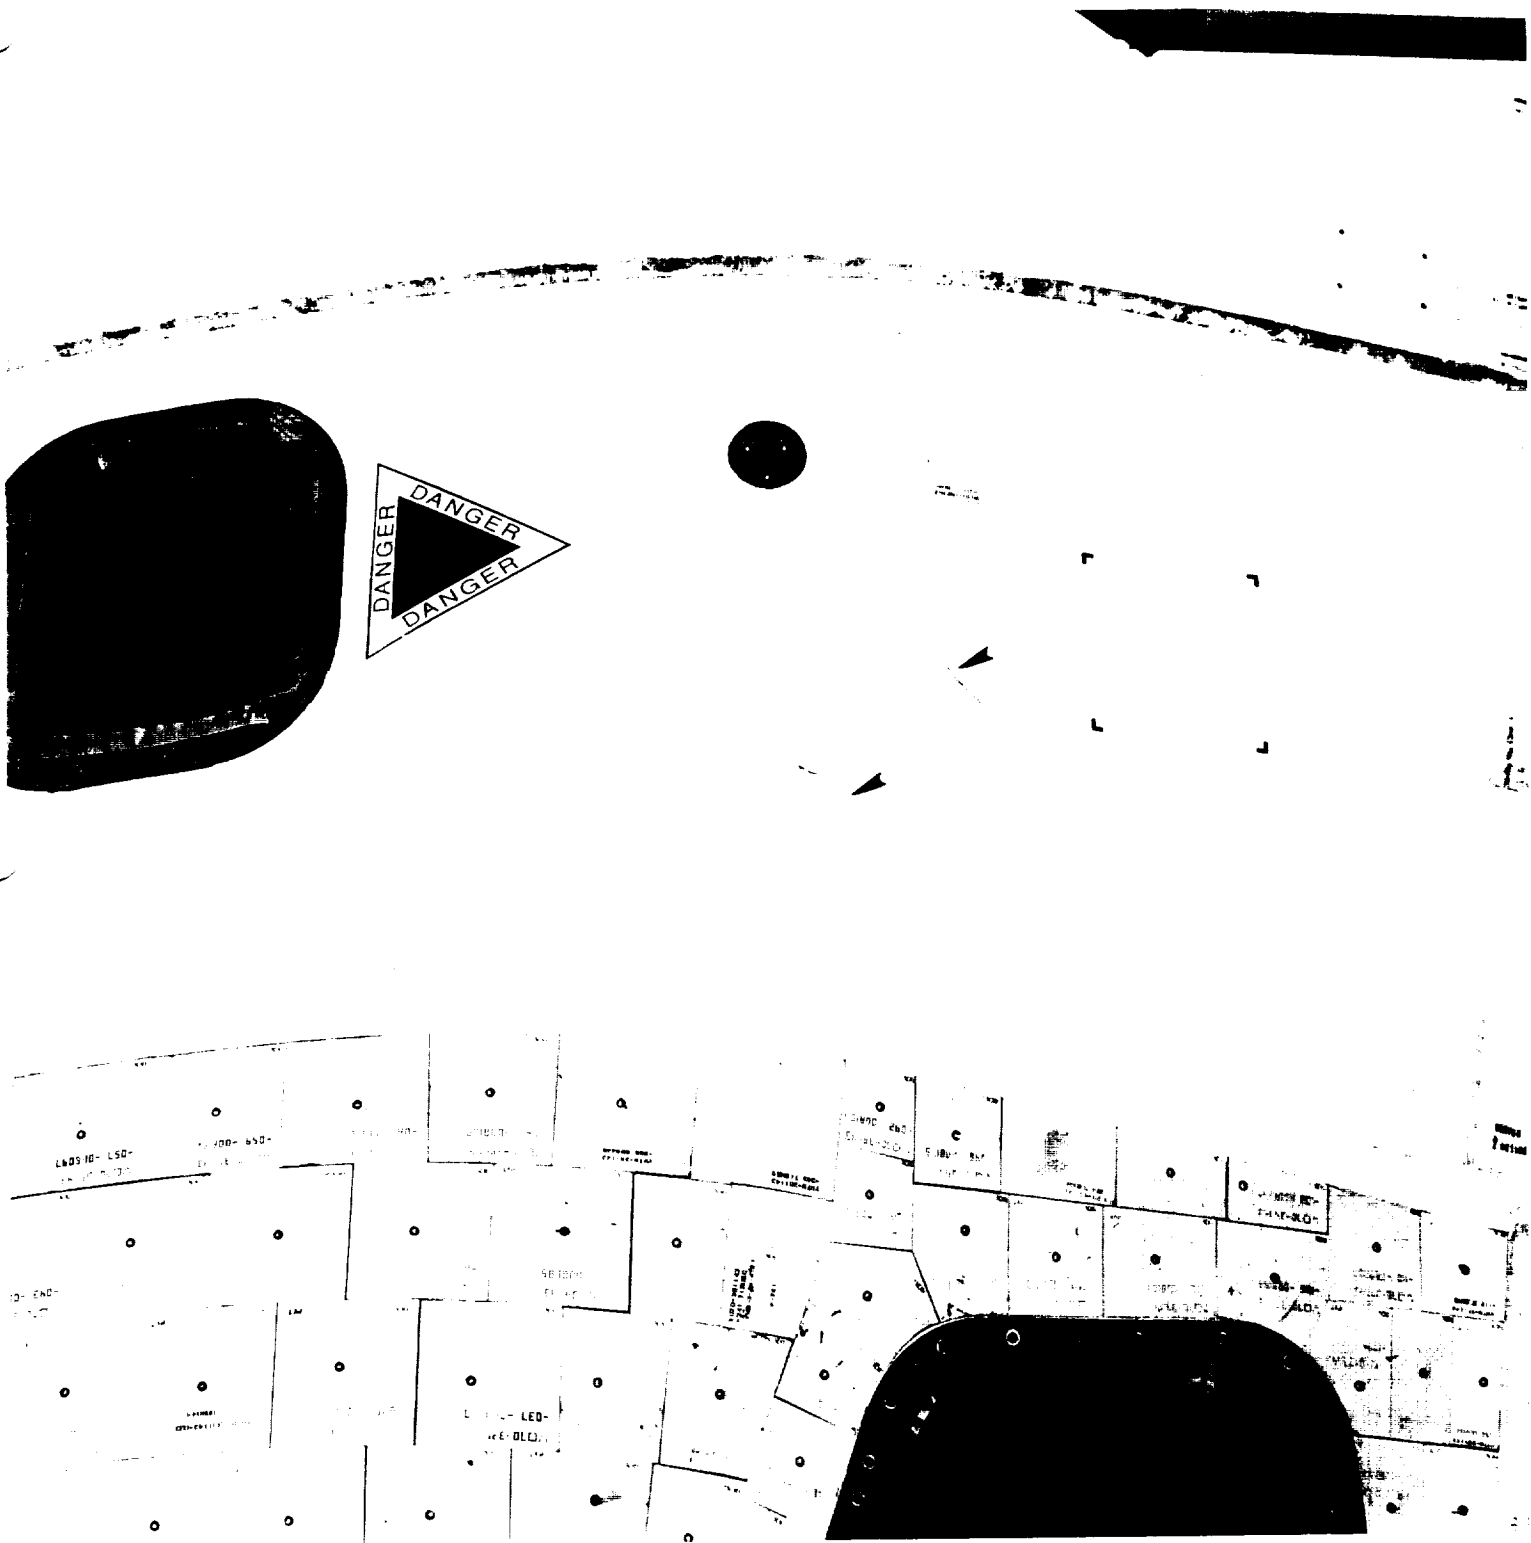
Photo 19: Hairline Cracks in Thermal Blankets

Approximately five cracks in the FRSI were noted on top of the crew cabin and on the left forward payload bay door ranging from 3-feet to 5-feet in length. Although not considered to be a result of debris impacts, the cracks were larger than previously observed.

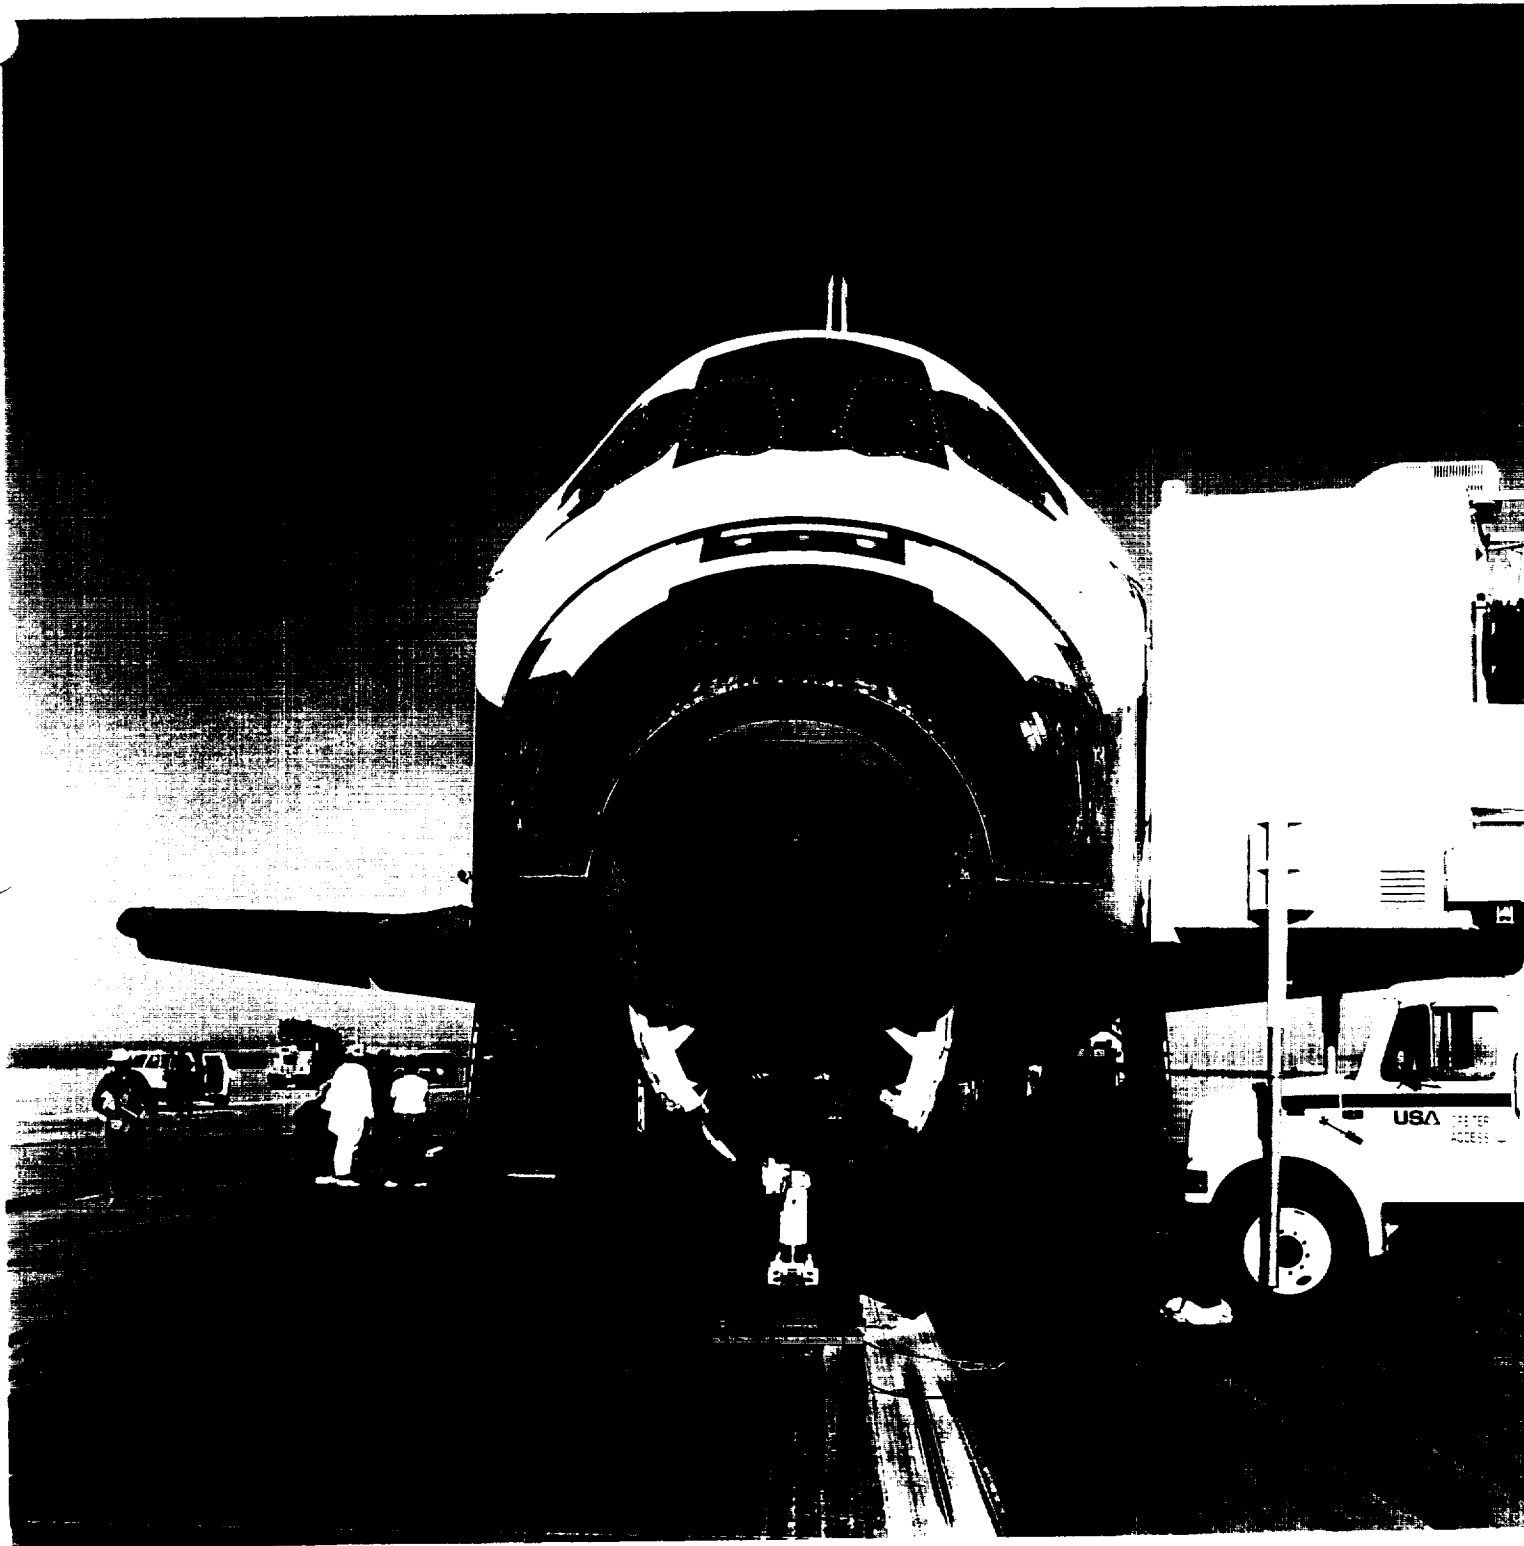
Photo 23: Windows

Damage sites on the window perimeter tiles appeared to be less than usual in quantity and size, with the exception of window #5, which sustained eight hits on the perimeter tiles. Hazing and streaking of forward-facing Orbiter windows was moderate. Window #5 had a small impact site on the lower aft portion, which may have been caused by an orbital debris impact.

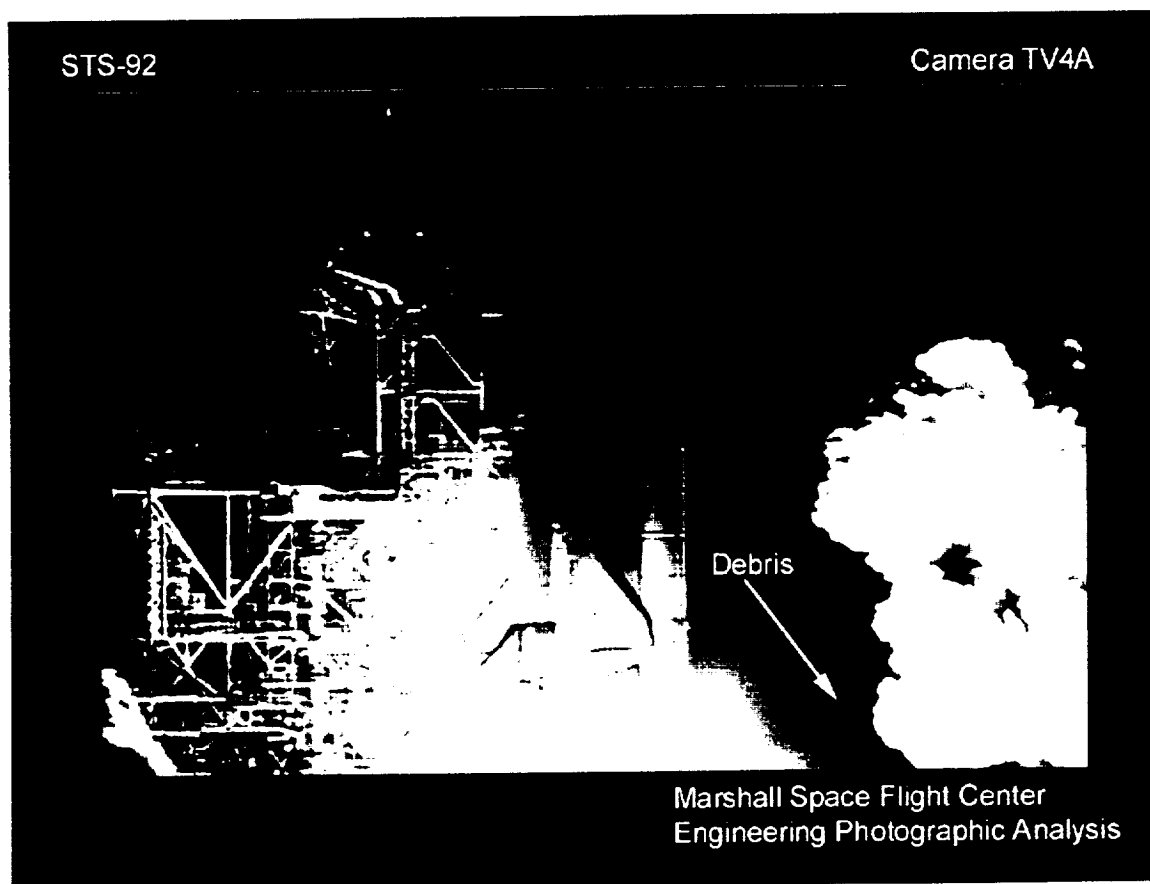
Figure 2. TV4A: Pad Debris at Liftoff

Typical pad debris was observed moving away from the vehicle during liftoff.
